# Customer Examples

# St. Louis Chemical Plant 75 HP TECO Motor

# Diagnostic Examples

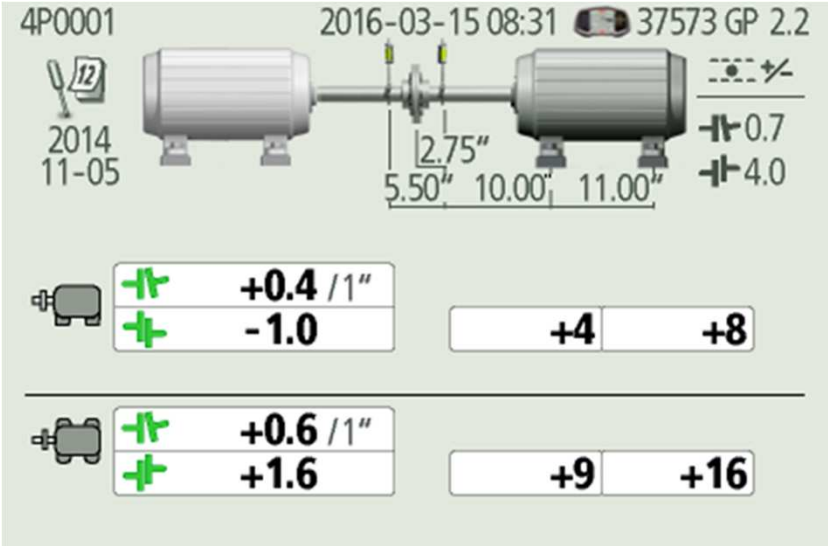
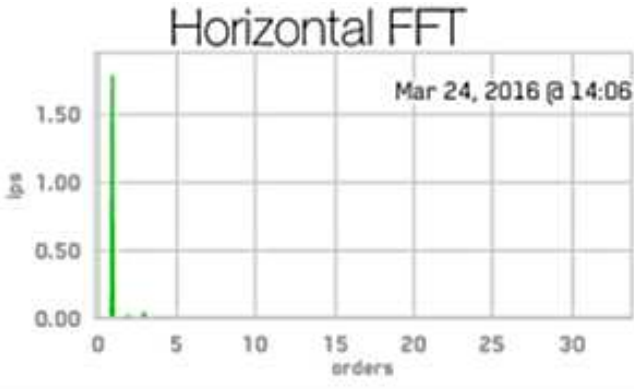
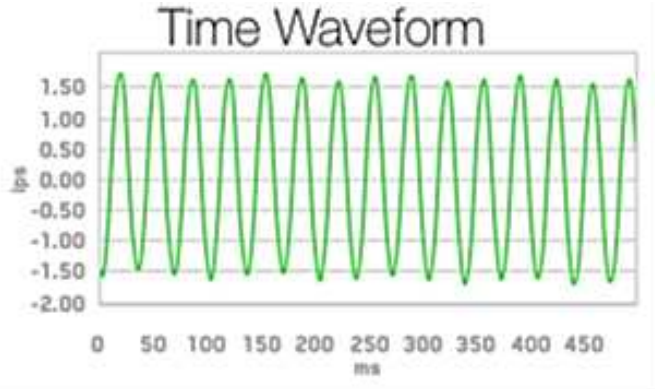
The Distributor rep returned to the site the next day and observed the equipment had already been placed in operation and found the *i-ALERT2* was recording vibration levels of over 1.7 IPS! Diagnostic data were collected from the *i-ALERT2* monitor and were sent to the distributor's vibration analyst while the equipment was switched over to the in-line spare.

The distributors vibration analyst utilized his multi-channel vibration analyzer to determine that the root cause of the vibration was that the **center of baseplate had broken free from the concrete floor and was flexing**. A temporary fix was implemented that lowered the vibration to 0.2 inches/second.

The customer has already put in a requisition for the Distributors team to engineer and install a permanent fix for the damaged baseplate.

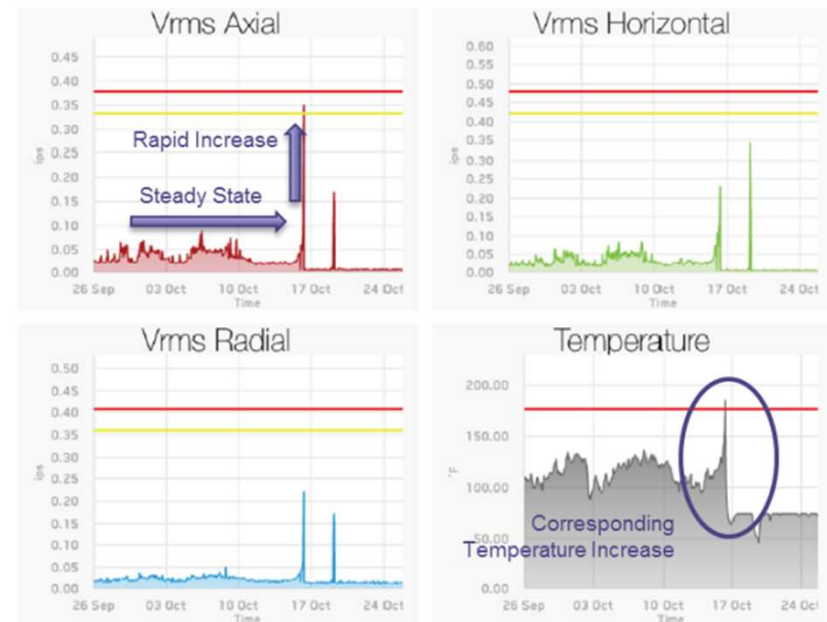
Pump failed again after just 427 hours of run-time

Time stamped trend data allowed the exact moment of failure to be cross referenced against process data the DCS which traced the failure back to an operational issue.

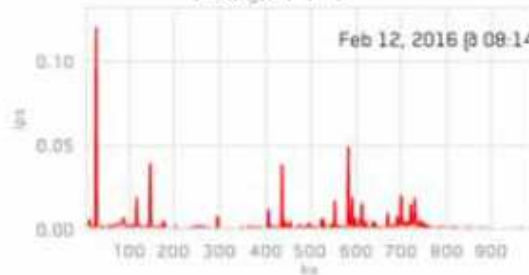
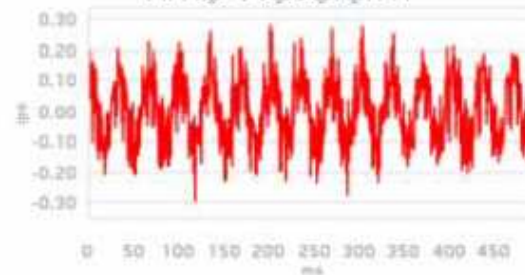
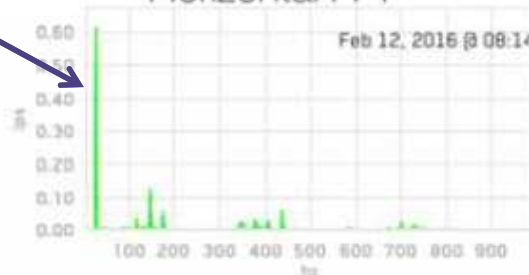
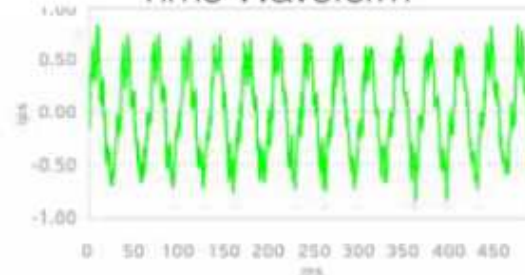
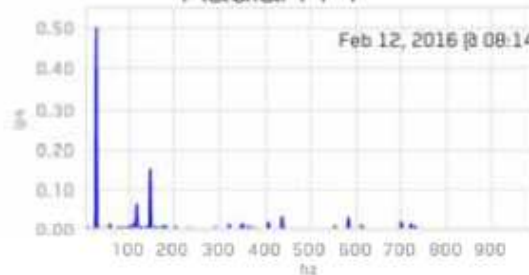
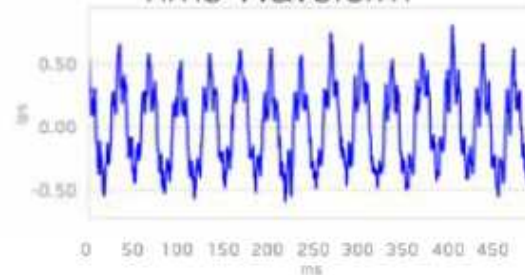
# Start-Up; Bent Shaft

Elevated 1x Peak in all directions indicative of Bent Shaft.

Physical measurements confirmed condition.

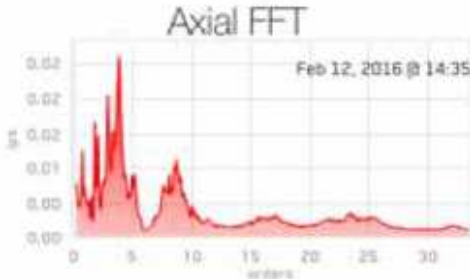
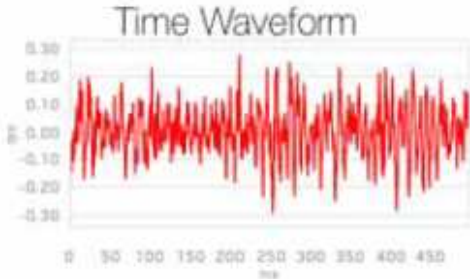
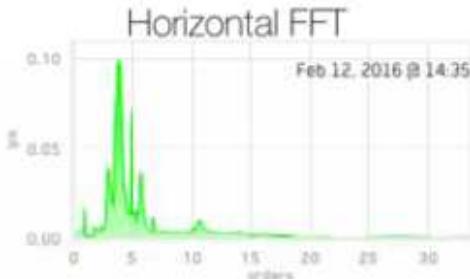
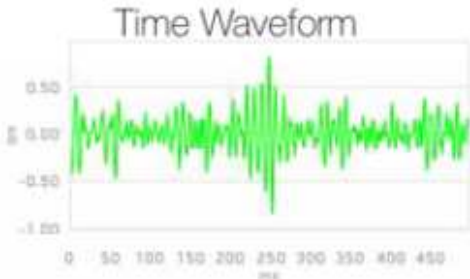
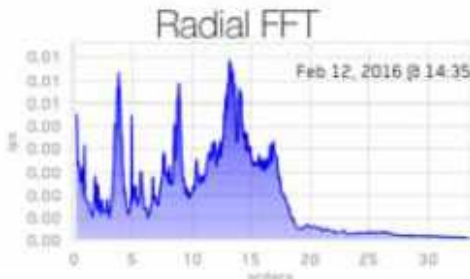
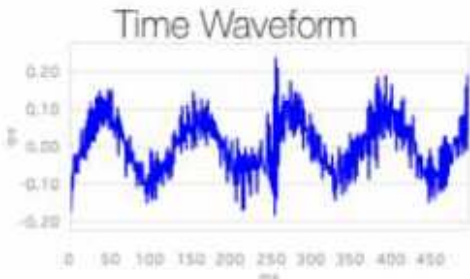
# Cavitation / Suction Recirculation

Broadband energy in FFT and Impacting in TWF indicative of hydraulic faults
